# Supplementary Certificate

## D-, PUA, PTA45-, K-, und M-

**changes in the lifting device**

## **I. Brief description of the changes in the lifting device**

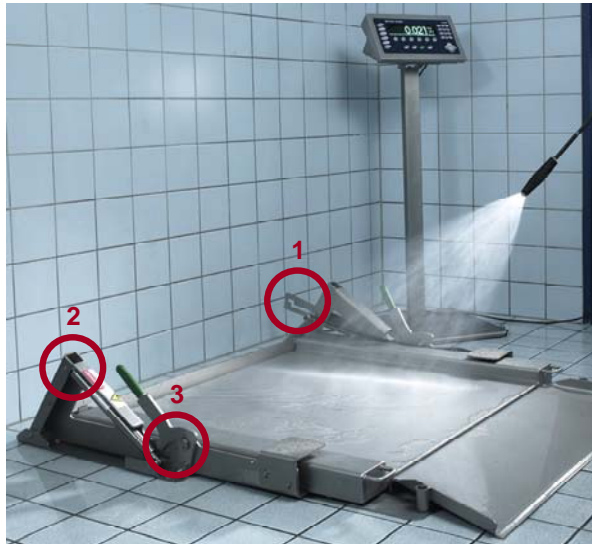
Fig. 1: Lifting device in the position for weighing

The figure one of the following page shows the lifting device in the weighing position. Item 1 to 3 are marked with red circles.

Item 1: (see fig. 1 and 2) Insertion of a safety catch

Item 2 (see fig. 1 and 2) Change in the position of the gas strut

Item 3 (see fig. 1 and 2) additional insertion of the stopping levers

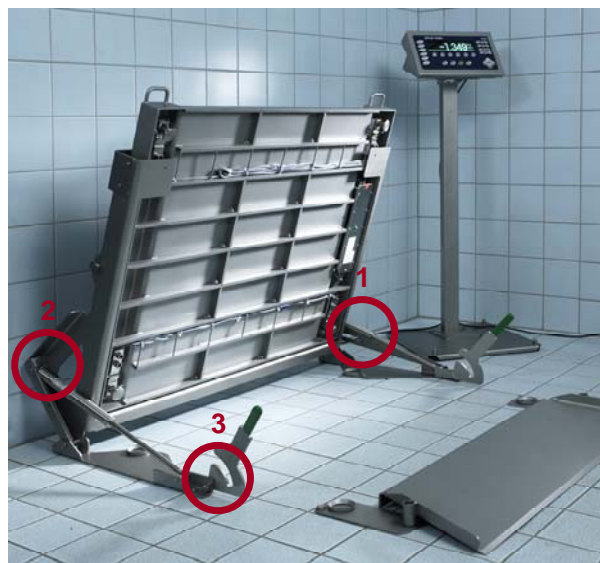
Fig. 2: Lifting device in an upwards position

The figure two shows the lifting device in the upwards position. The items 1 to 3 are marked with red circles.
